SmokeSight 10

Product Bulletin No.2

SmokeSight – Smoke alarm sensor, contaminant sensitivity

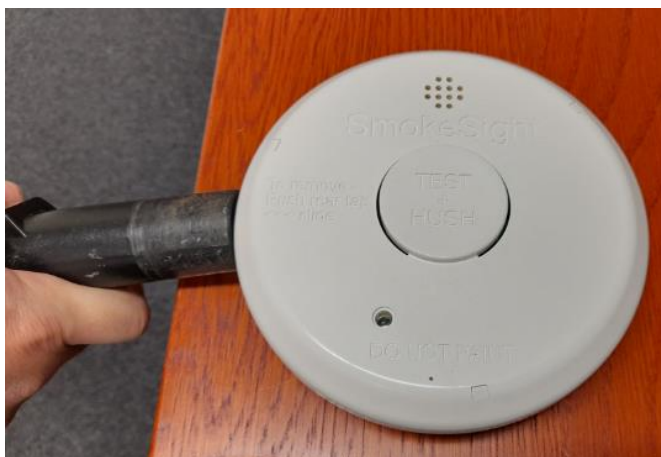
3, low volume chirps every 40 to 50 secs. No corresponding LED indications. Chirping is local to an individual smoke alarm unit.

Smoke alarm has been exposed to lint or fibre contaminants, and
Internal smoke sensor, component failure threshold too high

- Clean the smoke alarm, sensor chamber using a vacuum or clean, dry, compressed air (available in a can). Do not use an air compressor as the air is not dry or clean. Place the nozzle near the alarm lip and adjacent to the wording “To remove – Push rear tab <<< slide” as follows:
